Integrated
Surface
Technologies

Repellix™ Supermolecular Ceramic Coating Humidity Test

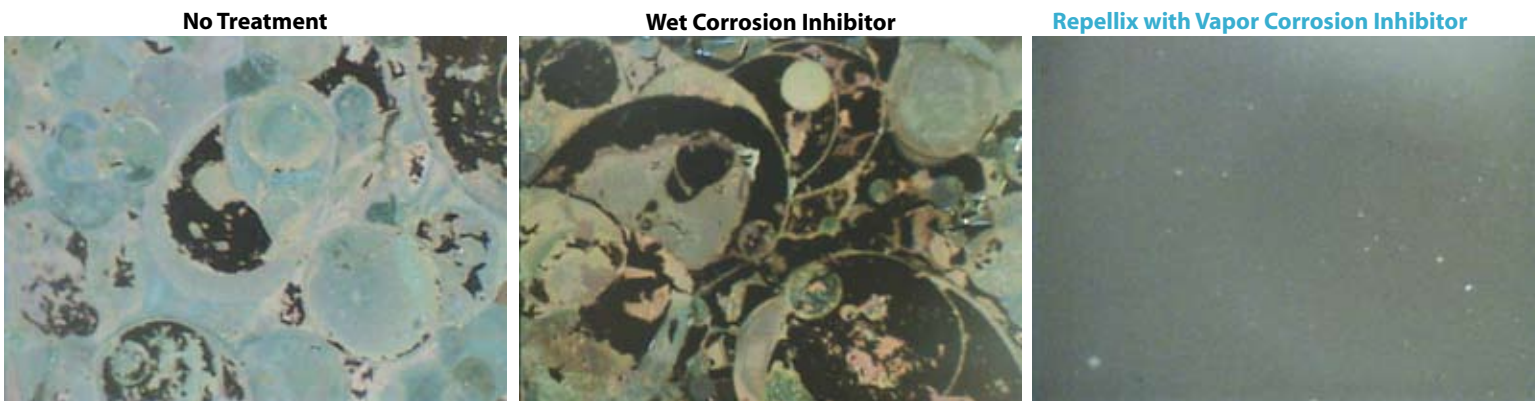
Microscope Images (10X) Post Humidity

At 10X magnification, we observed significant surface degradation in all cases where the samples did not have a Repellix protective coating. As the above samples show, the industry standard liquid treatment had some minor retardation of the corrosion, but not

nearly as dramatic as a Repellix treatment (right). The Repellix coupons showed significantly reduced corrosion in all cases. Small bubbles of corrosion are only beginning to form in pinholes whereas the other treatments showed advanced damage .
